## **Composite Failure Analysis Handbook Update #1**

*Greg Walker*

*Boeing Defense & Space Group*

**April 1995**

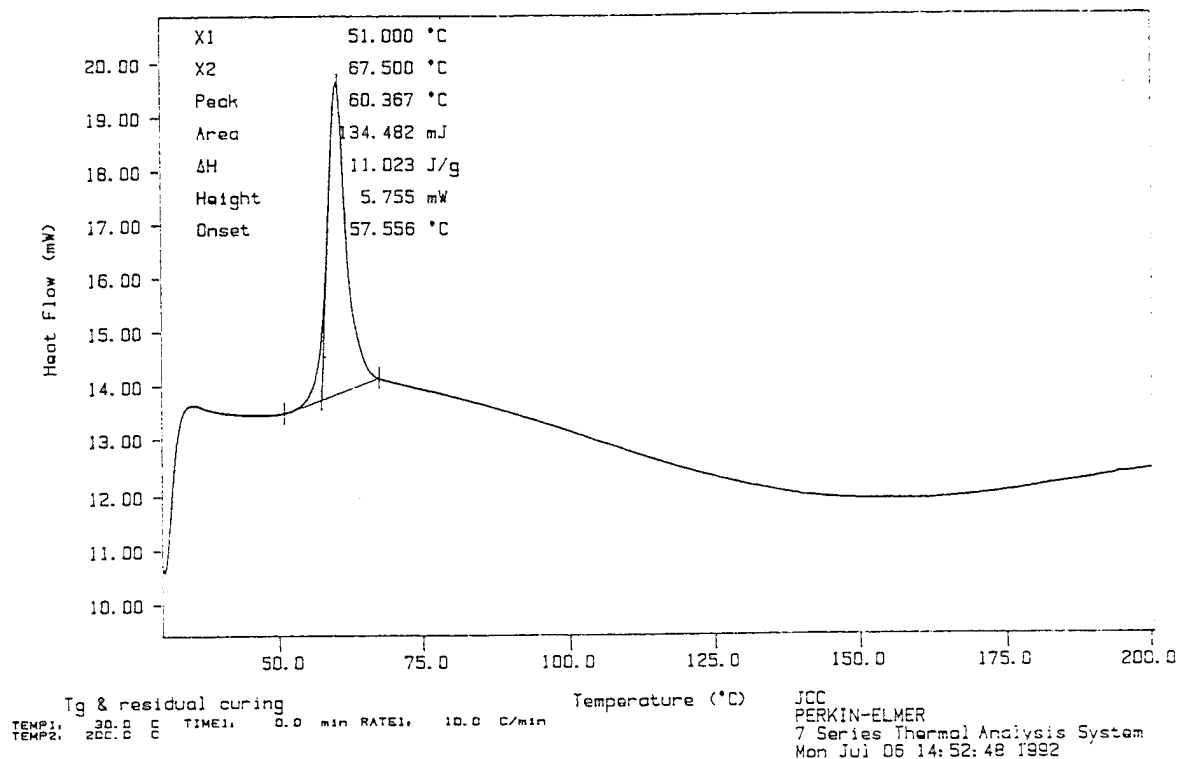
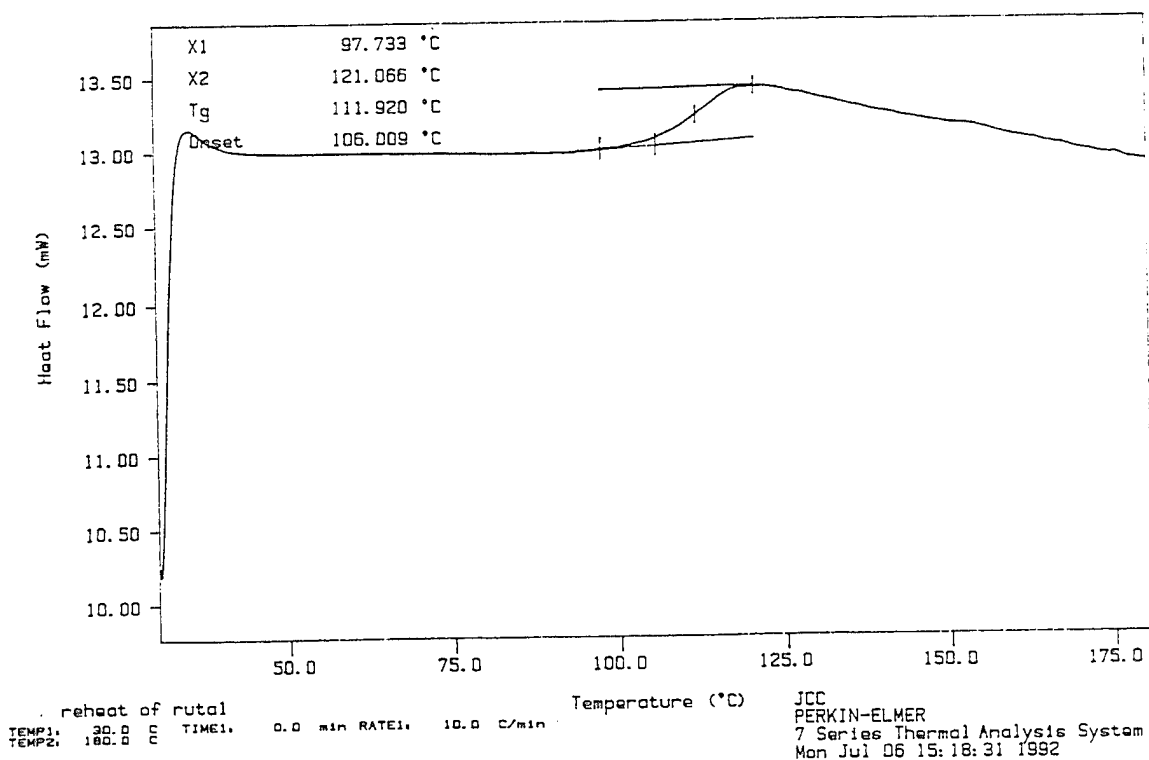
Figure 6. DSC Plots of the Non-Post-Cured Rutapox Sample

Differential Scanning Calorimetry (DSC) analysis was used to determine the extent of curing and the glass transition temperature (Tg). A sample of un-cured epoxy resin was analyzed two times with an exothermic reaction occurring on the first pass. An exothermic reaction did not occur on the second pass but a Tg of 112° C was observed. The next specimen from the wing section was also analyzed twice. No exotherms were

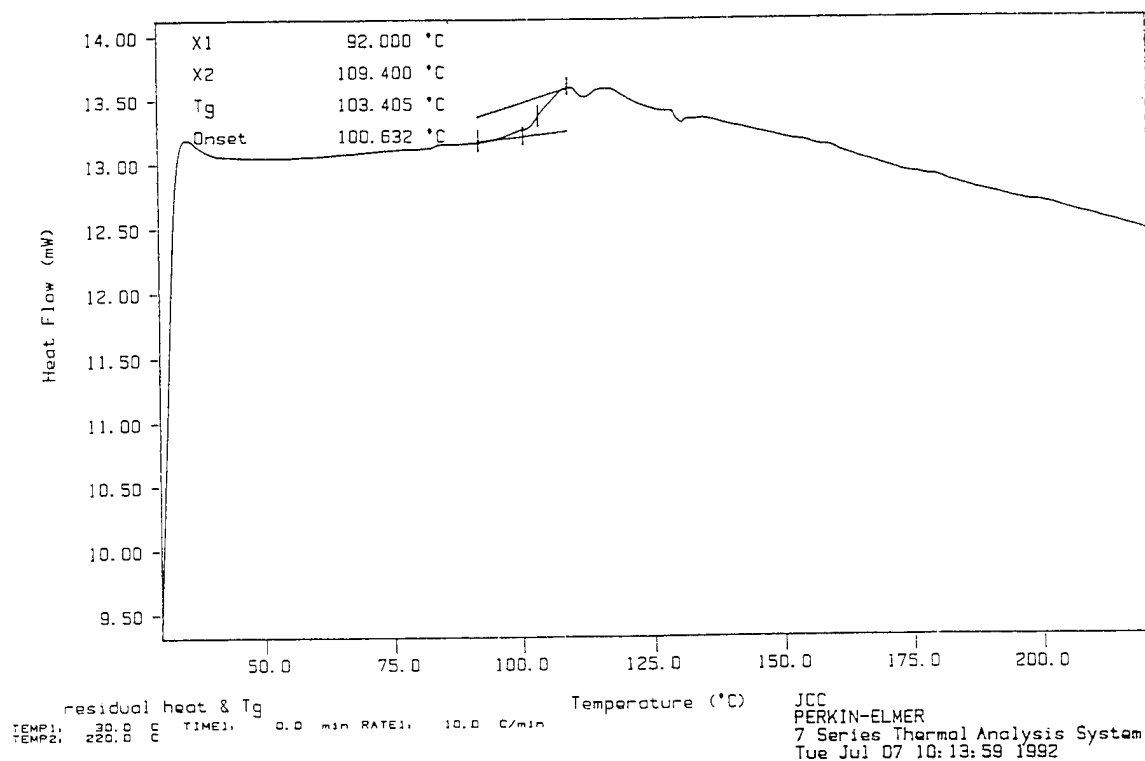
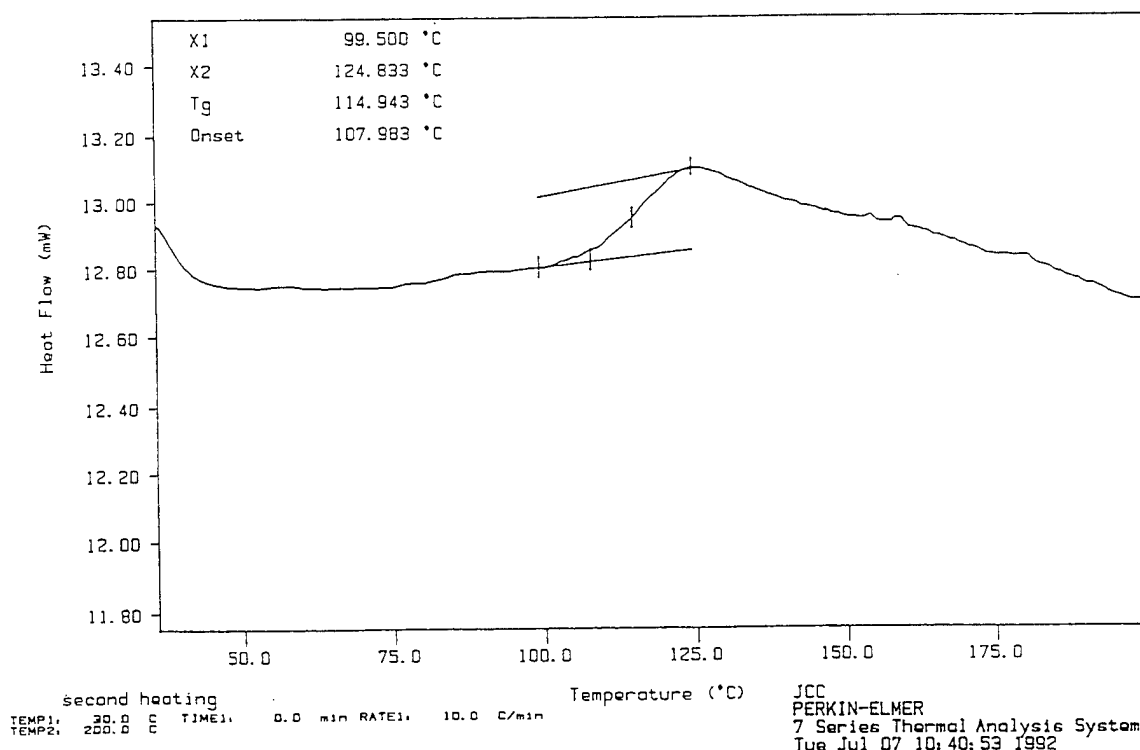
Figure 7. DSC Plots of the Wing Section Specimen

observed on either analyses and the Tg was 103° C and 115° C for the first and second tests respectively. This indicates that the resin in the wing section had been fully cured (Figure 6 & 7).

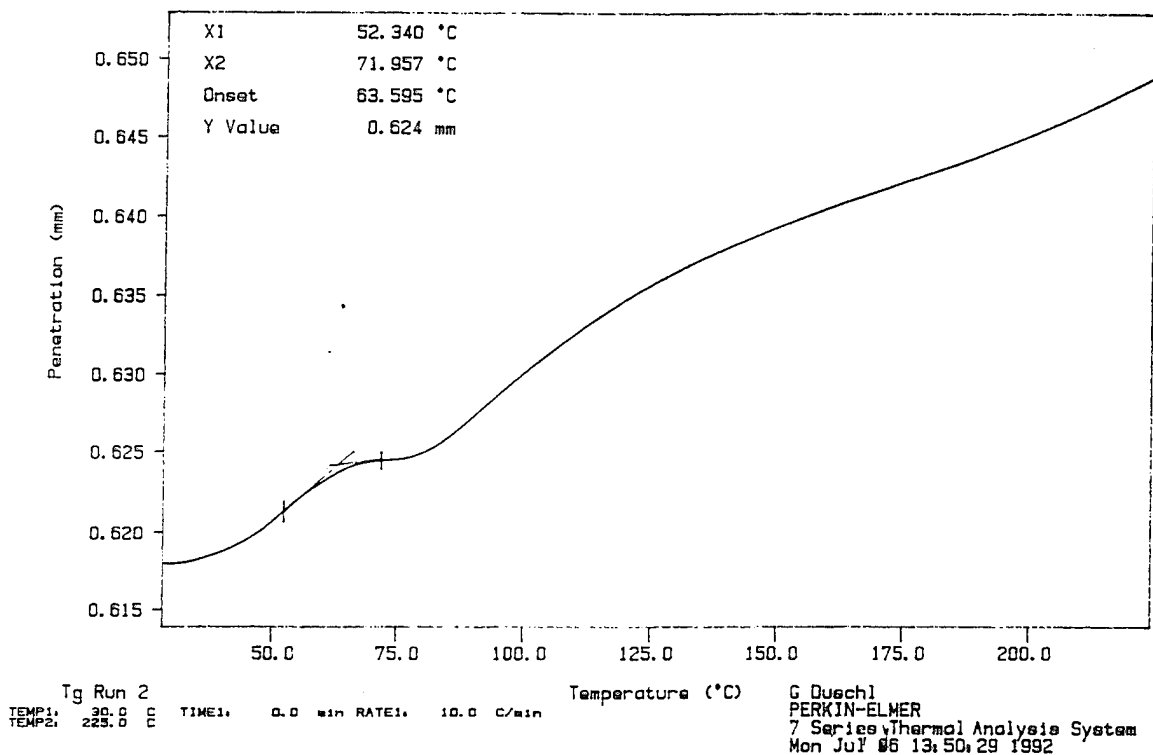
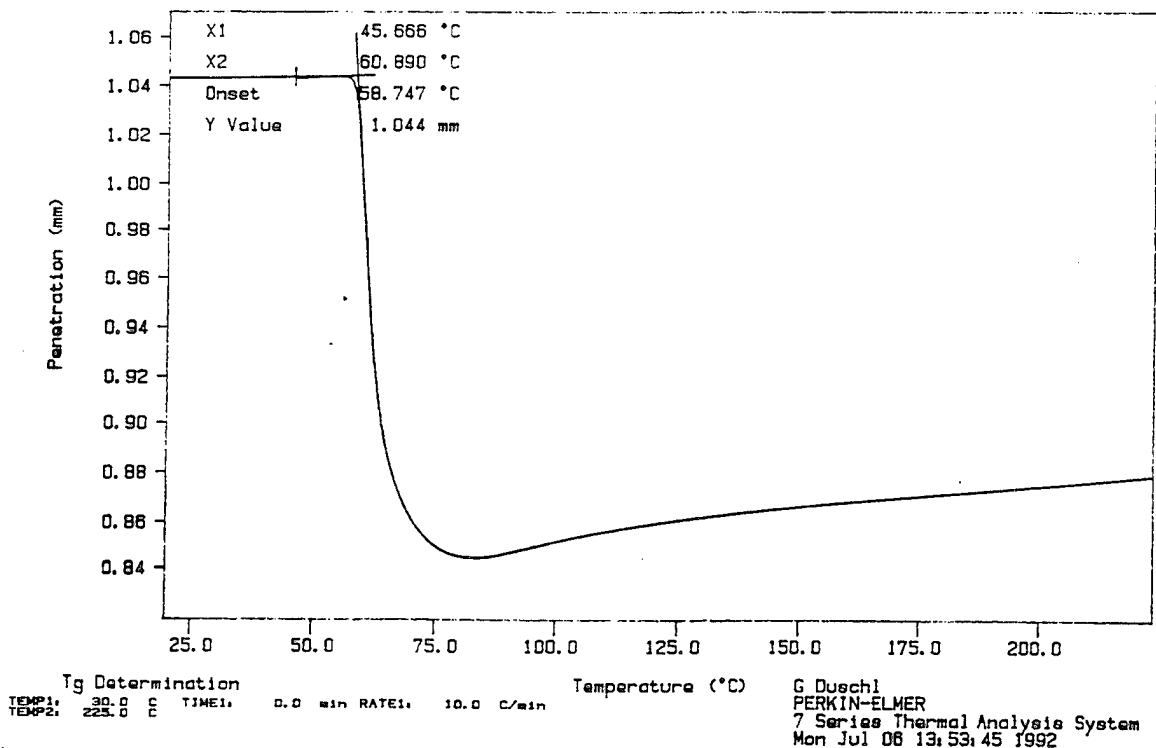
Figure 8. TMA Plots of the Non-Post-Cured Rutapox Sample

Thermo-mechanical Analysis (TMA) is another method to determine the Tg of a polymer. Again two specimens were tested; a non-post cured sample and a sample from the wing section. The first heat cycle of the non post-cured specimen revealed a definite Tg indication at 59°C. Testing of the resin from the wing revealed a Tg of 110°C and 107°C from the first and second runs, respectively. The difference between these two tests confirmed that the wing sample was fully cured because the Tg values were similar to the DSC analysis and that the uncured specimen exhibited a lower Tg and an exotherm. (Figure 8 & 9).
